30th MARCH 2024

Energy Audit Report

St. Xavier's College Jaipur

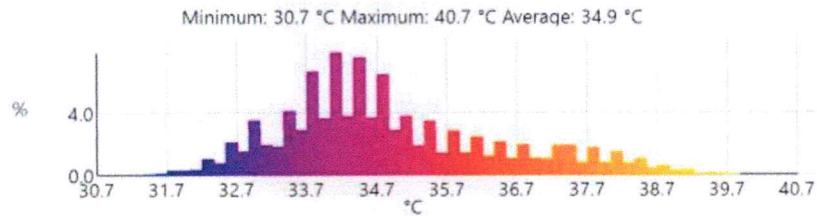
Histogram:

Measurement Objects	Temp. [°C]	Emiss.	Refl. temp. [°C]	Remarks
Cold spot 1	30.7	0.95	20.0	-
Hot spot 1	40.7	0.95	20.0	-
